## **AWRI Lake Restoration and Project Clarity Photography**

Dr. Alan Steinman, Director and Professor

Grand Valley State University, Muskegon, MI

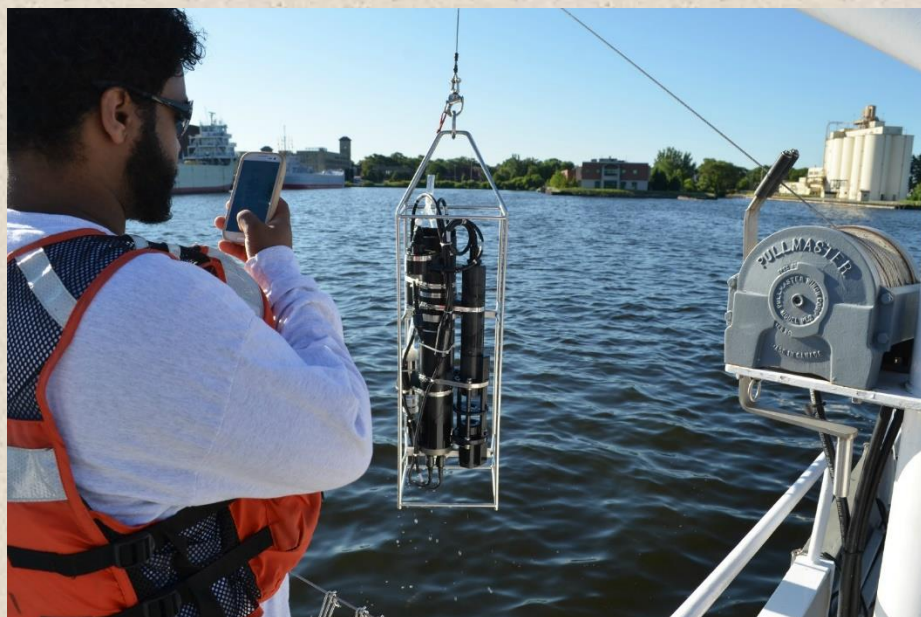
Figure 2: Sophisticated sensors are lowered through Muskegon Lake's water column to record water quality information that is used to characterize the lake's status.

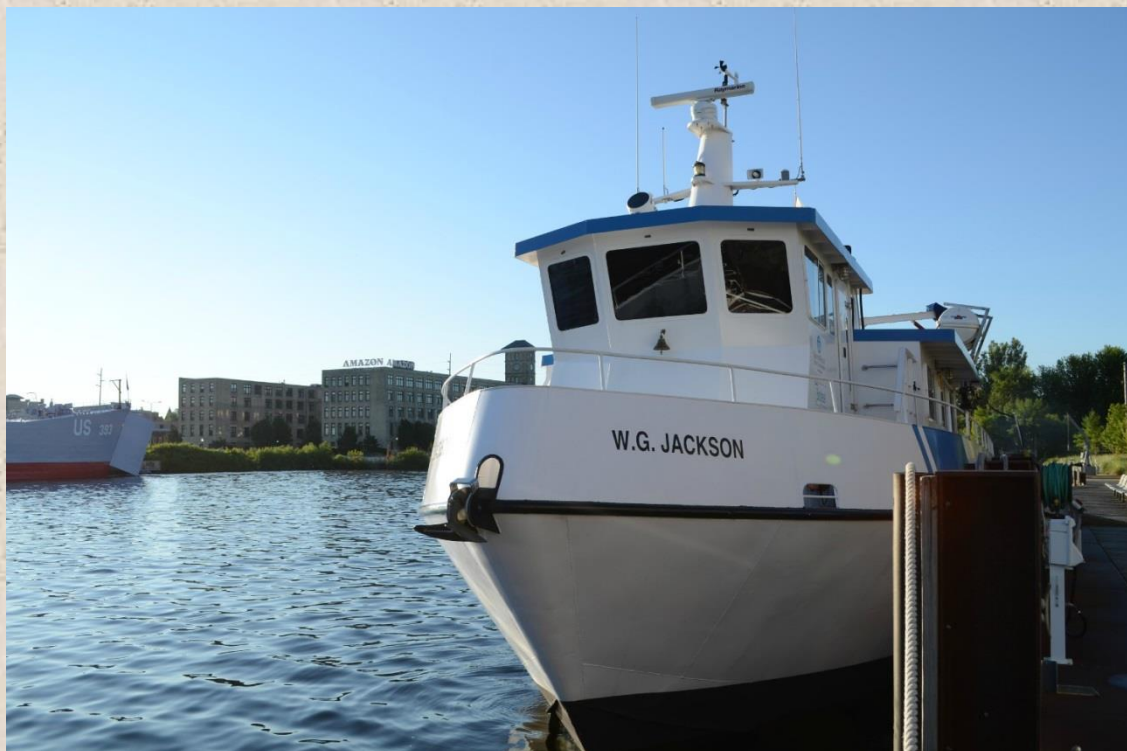
Figure 5: AWRI operates two research vessels in support of its Education and Outreach program and research efforts. Sample collection for the Muskegon Lake long-term monitoring program takes place from the *W.G. Jackson*, pictured here.

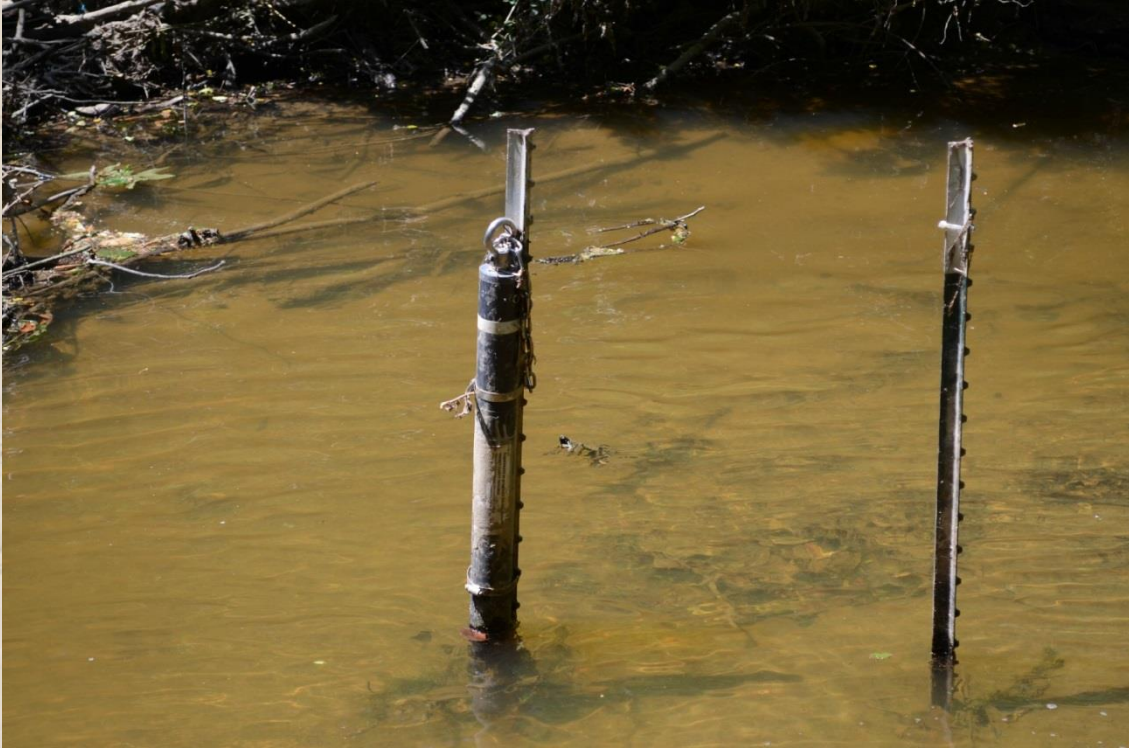
Figure 7: Part of AWRI's Project Clarity monitoring involves documenting the actual *clarity* of the water in the Macatawa River, which is the main source of water to Lake Macatawa. Turbidity sensors placed in the stream continuously measure turbidity levels.

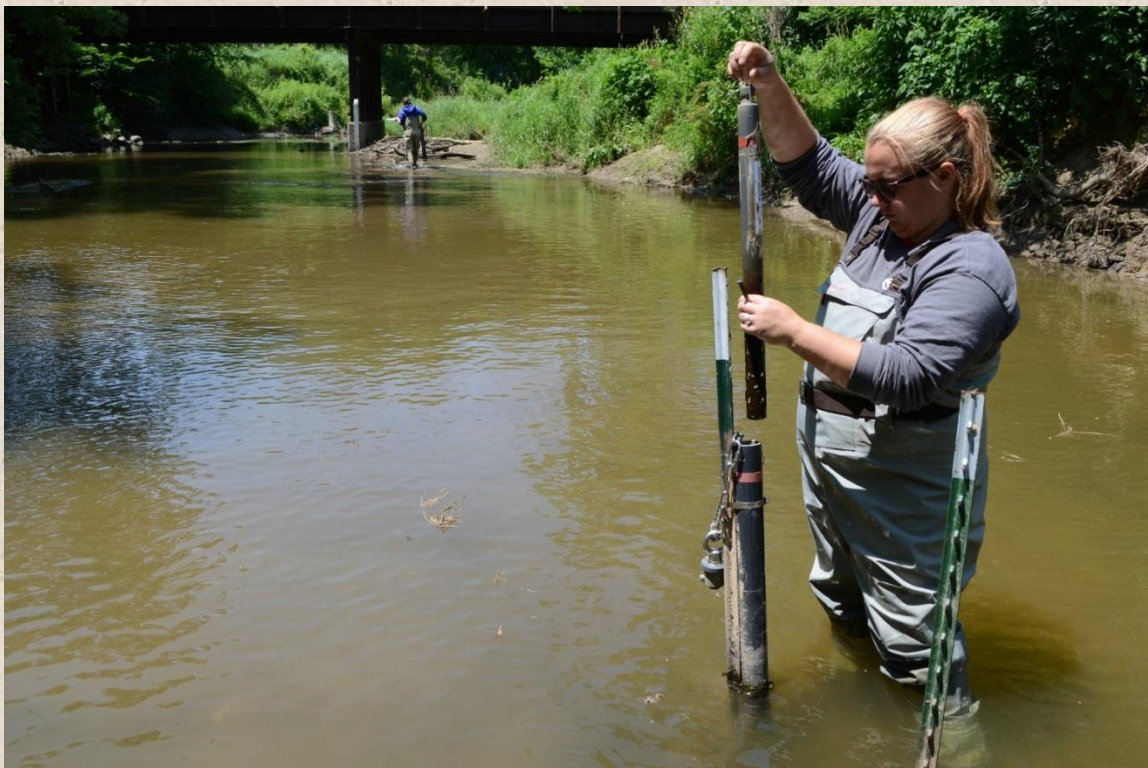
Figure 8: Regular maintenance of the turbidity sensors ensures they will collect high quality data that can be related to restoration activities, helping to document their effectiveness.

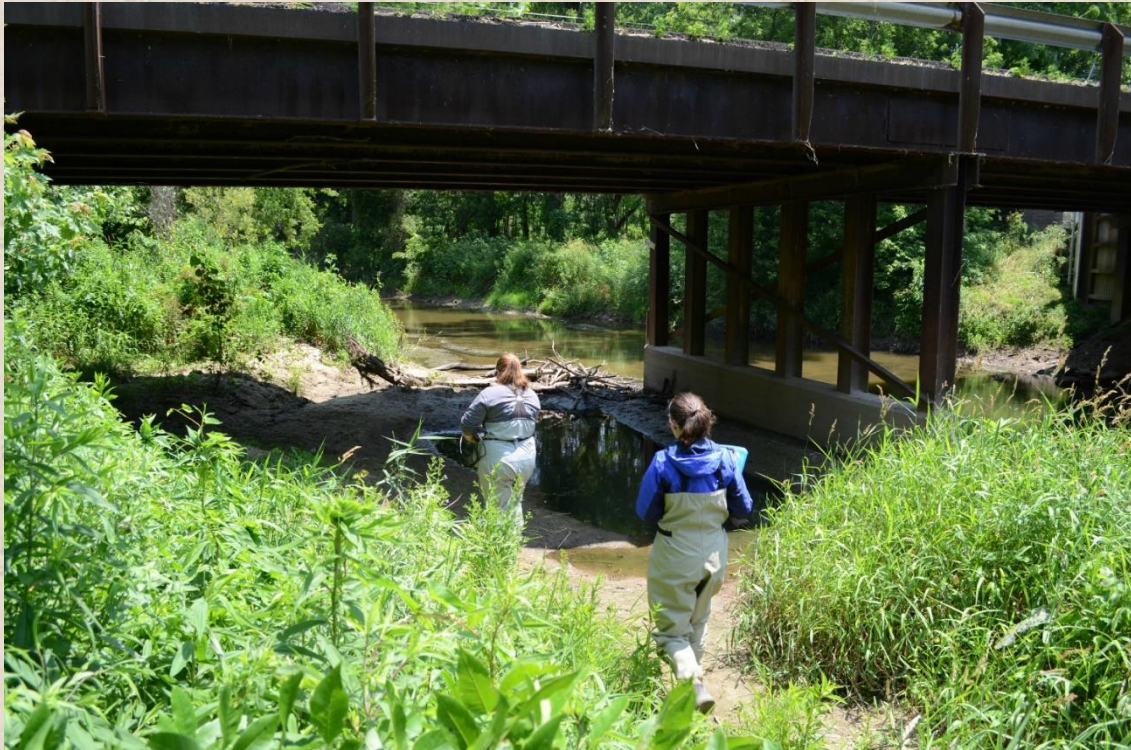
Figure 9: Data gathered during year-round, monthly visits to key restoration areas within the Macatawa watershed are being used to track the effectiveness of efforts to clean up the water that flows into Lake Macatawa.

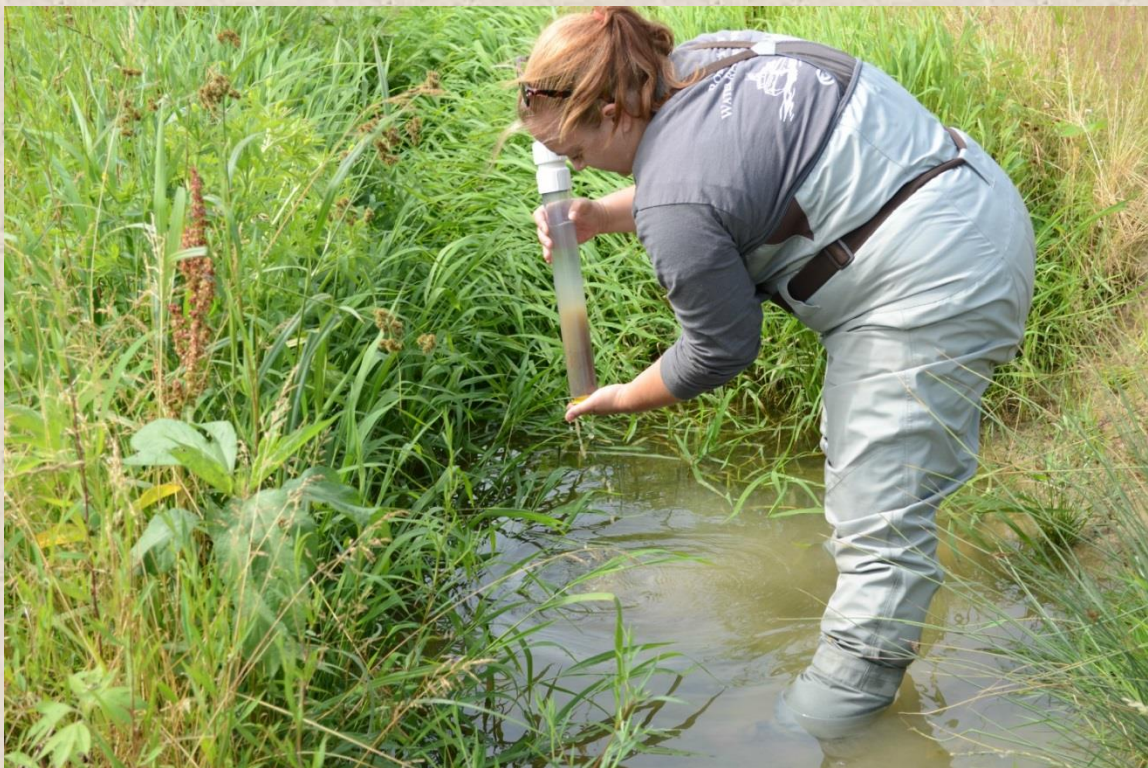
Figure 10: Agricultural best management practices (BMPs), such as this two stage ditch, are being monitored to assess their effectiveness in reducing sediment and nutrient inputs to Lake Macatawa. Here, a sediment core is being collected for analysis of phosphorus content.

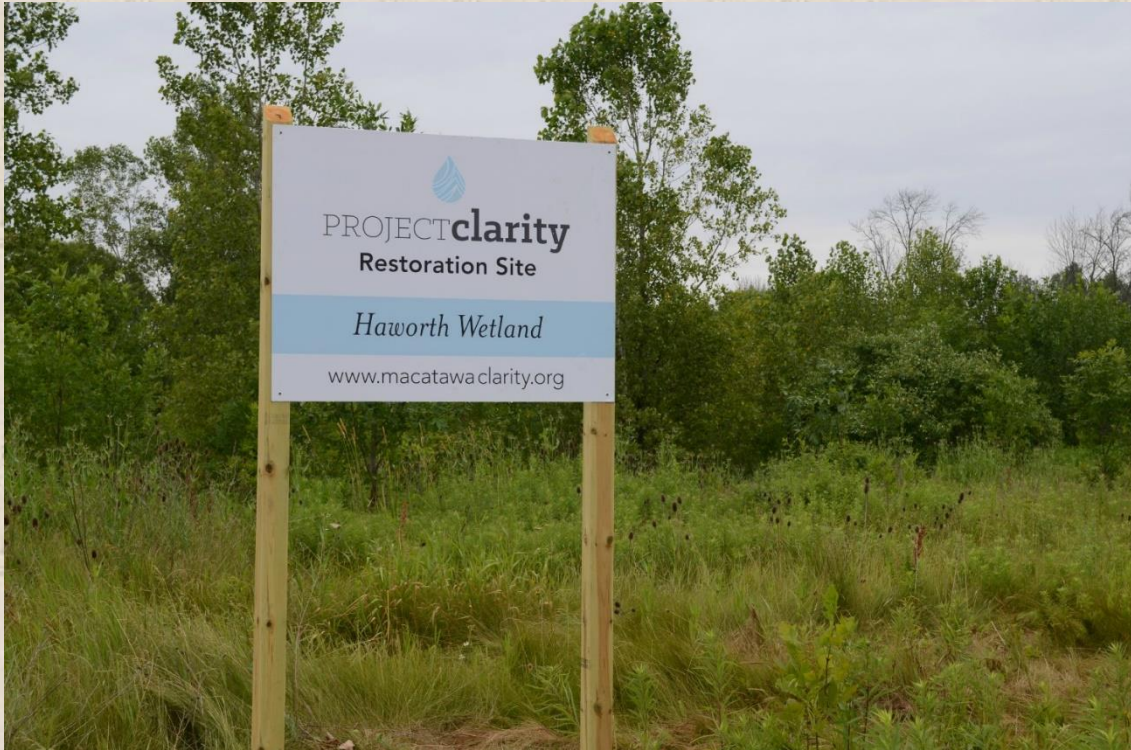
Figure 11: Wetland restoration areas are being created within the Macatawa watershed to help reduce the flow of water to Lake Macatawa during rain events, thus keeping excessive sediment and nutrients on the land and out of the lake.

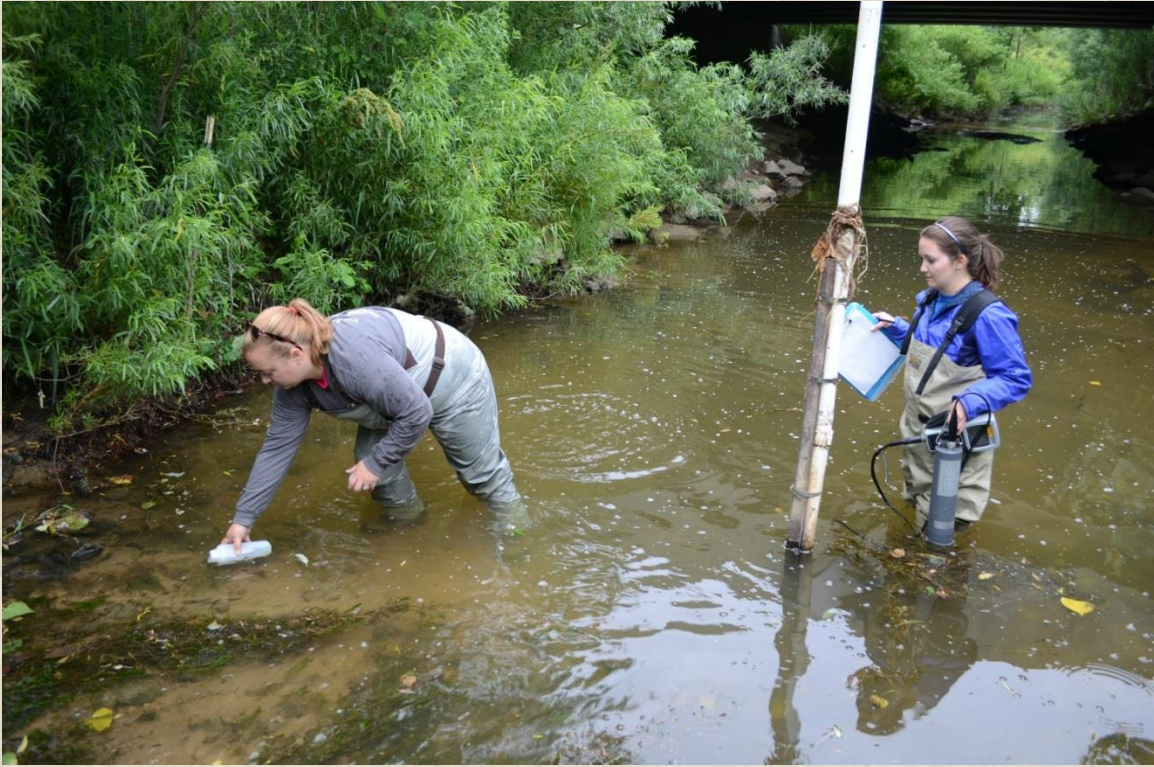
Figure 12: Nutrients and other key water quality parameters are measured upstream and downstream of the restoration areas during both dry and wet weather.
